Navajo Abandoned Uranium Mine

Site Screen Report

Canyon No. 1 AUM Site

March 2010

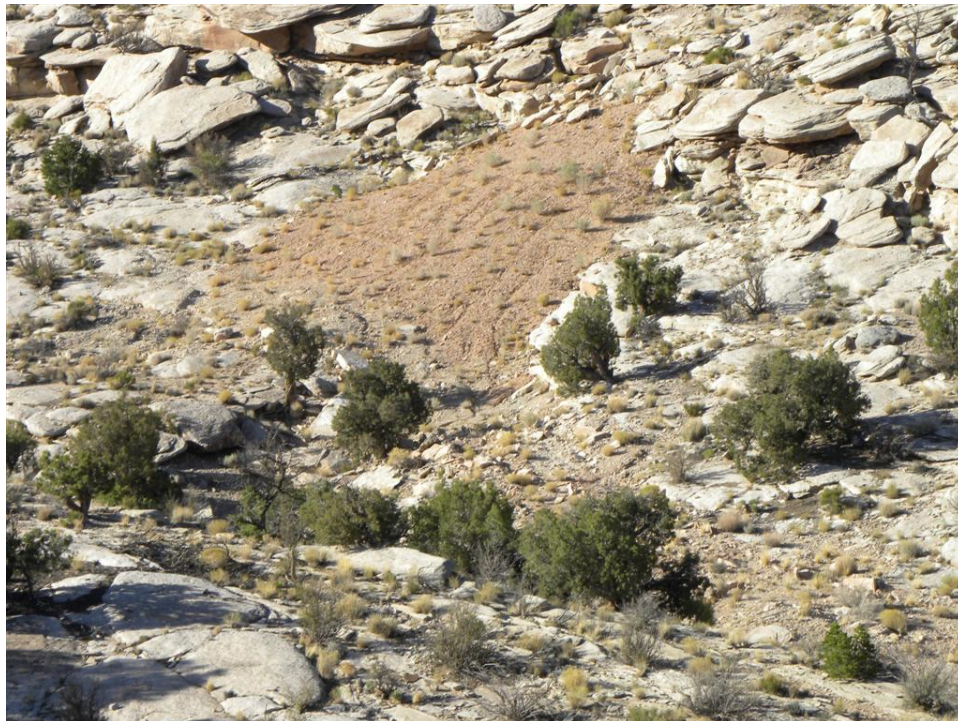
A small reclamation cap in the northwest portion of the site

Photo 2. Reclamation cap

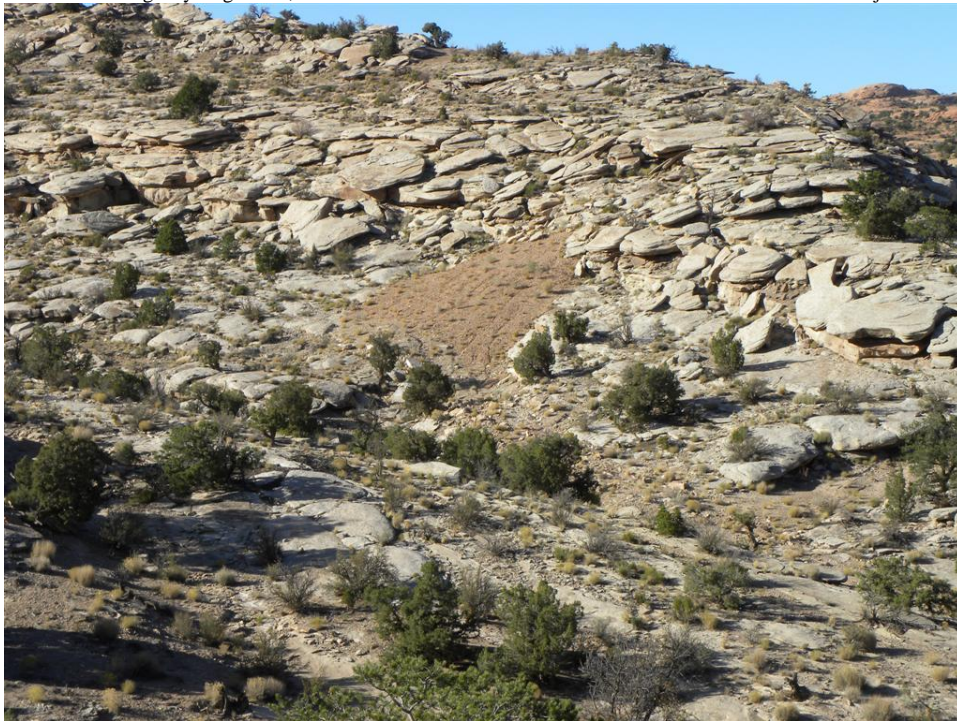
Photo 3. Reclamation cap
